SUBJECT: ADDENDUM NO. 2
JUDICIARY PROJECT NO. J17180
ALI'IOLANI RELOCATION, RECARPET AND REPAINT SUITE 103
PROJECT IDENTIFIER: JUD-SC-ALIIHALE-103CPTPT-1617
THE JUDICARY, STATE OF HAWAII, TAX MAP KEY: 2-1-025: 003

Asbestos, Lead Paint, PCB Ballast and Mercury Lamp Survey Report

Ali'iolani Hale

Judiciary Condition Assessment

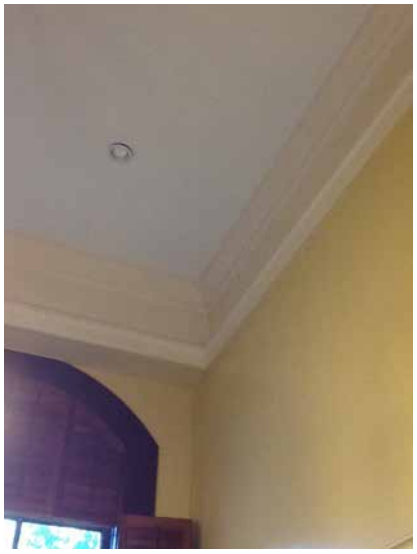
PHOTOGRAPH

Total Number of Samples Collected	3
Samples Collected by	EMET
Sample Numbers	498-AH-2H1, 498-AH-2H2, 498-AH-2H3
Total Number of Samples Analyzed	3
Samples Analyzed by	EMET
ASBESTOS-CONTAINING MATERIAL ?	**NO**
Number of Salient Designations:

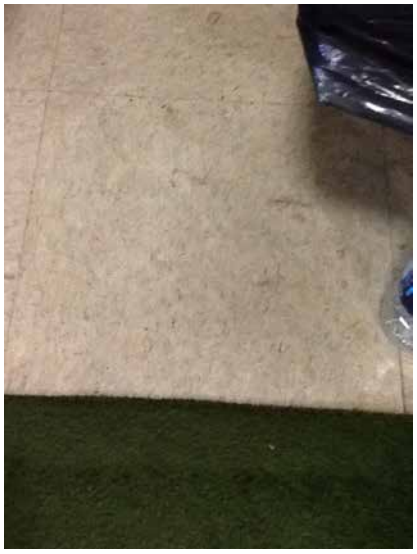
PHOTOGRAPH

Total Number of Samples Collected	3
Samples Collected by	EMET
Sample Numbers	498-AH-2X1, 498-AH-2X2, 498-AH-2X3
Total Number of Samples Analyzed	3
Samples Analyzed by	EMET
ASBESTOS-CONTAINING MATERIAL ?	**NO**
Number of Salient Designations:

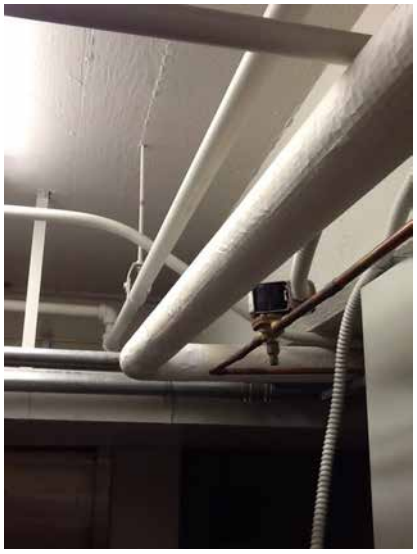
PHOTOGRAPH

Total Number of Samples Collected	3
Samples Collected by	EMET
Sample Numbers	498-AH-BA(L1)1, 498-AH-BA(L1)2, 498-AH-BA(L1)3
Total Number of Samples Analyzed	3
Samples Analyzed by	EMET
ASBESTOS-CONTAINING MATERIAL ?	**NO**
Number of Salient Designations:

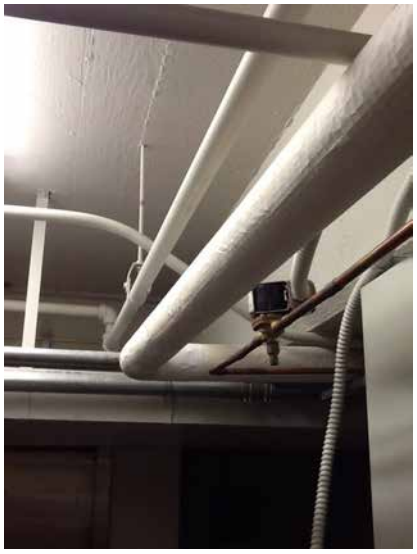
PHOTOGRAPH

Total Number of Samples Collected	3
Samples Collected by	EMET
Sample Numbers	498-AH-BA(L2)1, 498-AH-BA(L2)2, 498-AH-BA(L2)3
Total Number of Samples Analyzed	3
Samples Analyzed by	EMET
ASBESTOS-CONTAINING MATERIAL ?	**NO**
Number of Salient Designations:

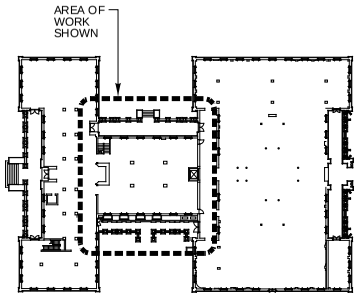
KEY PLAN: ALIIOLANI HALE - BASEMENT FLOOR

SAMPLE AREA 498-AH-1V: WATERPROOFING MATERIAL (INACCESSIBLE WITHOUT CAUSING ANY COSMETIC DAMAGE, NO SAMPLES TAKEN DURING TIME OF SURVEY - ASSUMED ACM)

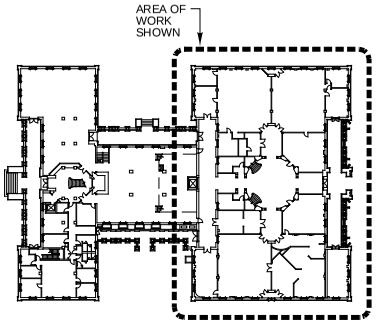
KEY PLAN: ALIIOLANI HALE - FIRST FLOOR

SAMPLE AREA 498-AH-1V: WATERPROOFING MATERIAL (INACCESSIBLE WITHOUT CAUSING ANY COSMETIC DAMAGE, NO SAMPLES TAKEN DURING TIME OF SURVEY - ASSUMED ACM)

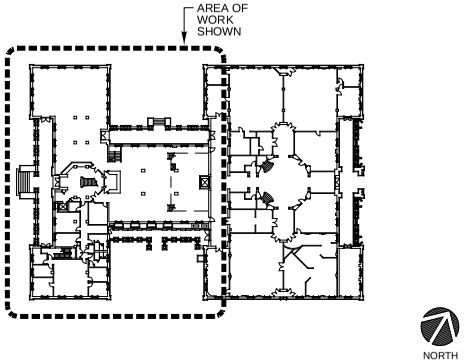
KEY PLAN: ALIIOLANI HALE - FIRST FLOOR

SAMPLE AREA 498-AH-2N: WATERPROOFING MATERIAL (INACCESSIBLE WITHOUT CAUSING 2ANY COSMETIC DAMAGE, NO SAMPLES TAKEN DURING TIME OF SURVEY - ASSUMED ACM)

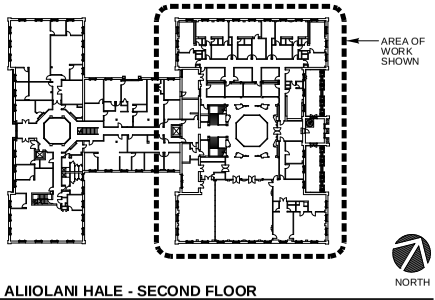
KEY PLAN: ALIIOLANI HALE - SECOND FLOOR

SAMPLE AREA 498-AH-2N:
WATERPROOFING MATERIAL (INACCESSIBLE WITHOUT CAUSING ANY COSMETIC DAMAGE, NO SAMPLES TAKEN DURING TIME OF SURVEY - ASSUMED ACM)
